# Manhole Inspection Summary

Manhole # S51A\_\_014MH

Insp Date: **5/6/08 11:39 AM**

**Location** Address: **rear 219 n linwood ave**

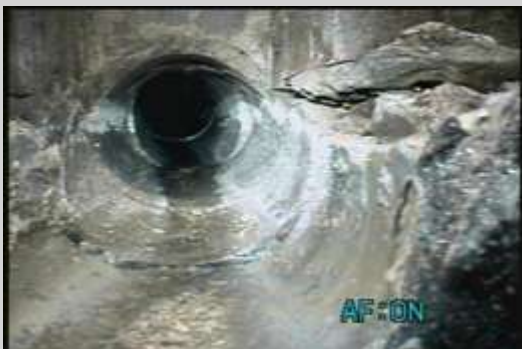
6 O'Clock Inflow

8 in. Circular Gravity Sewer  
Pipe In @ 6 O'Clock

Deposits: ☒ **None** ☐ Mud ☐ Sludge ☐ Debris ☐ Grease

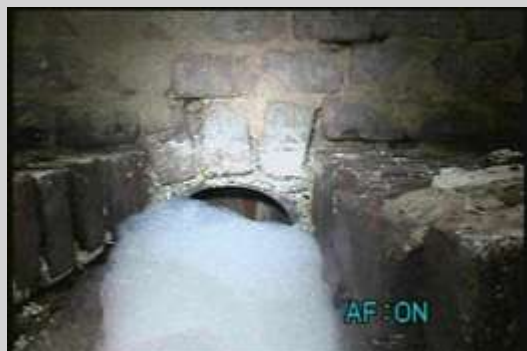
9 O'Clock Inflow

8 in. Circular Gravity Sewer  
Pipe In @ 9 O'Clock
